Development at Gowan Motors
Site, Naas Road

Walking Audit

Document Ref: P23063-PMCE-XX-XX-RP-QA-GEN-1_00_02

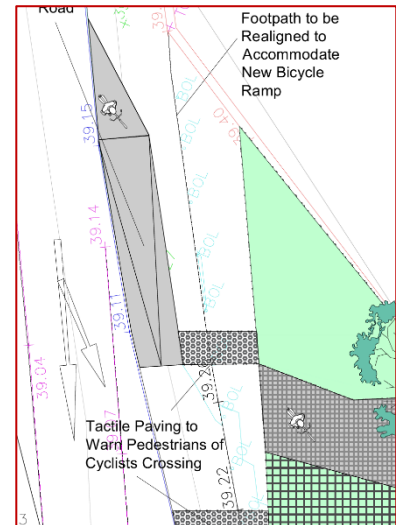
2.1 Ladder and Tramline at the start/end of shared facilities.

Tactile paving has been indicated on both sides of the access at the northwest of the proposed development where it is intended that cyclists would travel between the Naas Road and the development's underground Bike Store via this access. A ramp has been indicated at this location to allow cyclists to leave the Naas Road carriageway and enter the development.

Tactile paving has been indicated within the footway on both sides of this access however the type of tactile paving proposed is unclear. Should 'Ladder and Tramline' tactile paving not be provided on the north-eastern side of the access where the footway and cycle track transition to a shared path, this may result in visually impaired pedestrians, travelling northeast, inadvertently descending the ramp and entering the cycle.

In addition, should warning tactile paving not be provided on the south-western side of the access, there is a risk that visually impaired pedestrians may be insufficiently aware that they have entered/exited an area shared with cyclists, increasing the risk of cyclist-pedestrian collisions.

The Cyclist ramp on Naas Road should be removed and dropped kerbs (similar to dwellings vehicular access) should be provided to allow cyclists to access the development.

Should the Cyclist ramp on Naas Road be retained, 'Ladder and Tramline' tactile paving, of an appropriate depth, should be provided on the north-eastern side of the access and warning tactile paving should be provided on the south-western side of the access where the segregated facilities transition to the shared surface.

The profile of the Ladder and Tramline, and warning, tactile paving should be in accordance with, "Guidance on the Use of Tactile Paving Surfaces (2021)."

Walking Audit Reference	Summary of Issue	Design Team Response/Action
2.1	Ladder and Tramline at the start/end of shared facilities	The cyclist ramp at this location has been removed, and the footpath is now continuous along the side of the Naas Road.

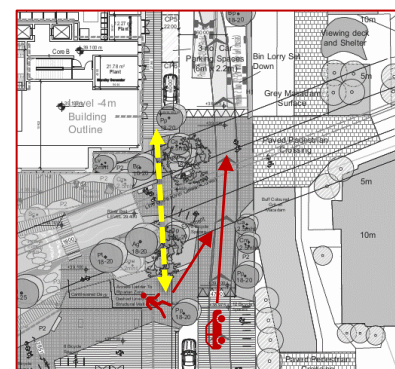
2.2 Discontinuous footway

A shared surface which would be traversed by vehicles, cyclists, and pedestrians has been indicated within the proposed development, however, a designated footway has not been provided for visually impaired pedestrians where they can travel without having to share space with motorised vehicles. The absence of a segregated footway may lead to visually impaired pedestrians being unable to safely and independently navigate the development.

A continuous segregated footway should be provided.

2.2	Discontinuous footway	Site Layout has been revised to provide a continuous footway at this location
2.3	Benches	The issue has been passed on to the Landscape Architect and will be picked up in their layouts

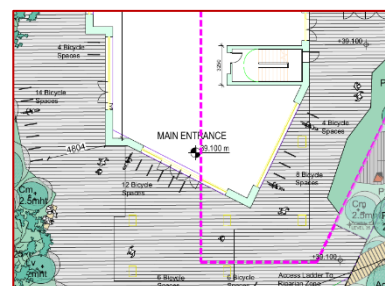
2.4 Blocked Building Access

Cycle parking stands have been indicated in front of the main entrance to Block 2. Bicycles stands and bicycles may block the access to the building.

The bicycle parking stands should be relocated.

2.4	Blocked Building Access	Bicycles have been relocated to avoid any blockages
2.5	The absence of continuous pedestrian accesses/links to Carriglea	Future Potential linkages to Carriglea are now indicated on the landscaping drawing.

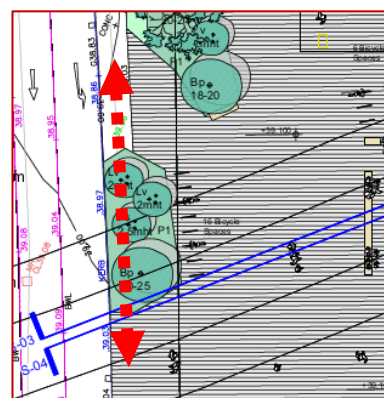
2.6 Tree Pit within Existing Footway

A tree pit has been indicated within the existing footway on the Naas Road to the southwest of the proposed development. This would obstruct the desire line of pedestrians travelling along the existing footway on the Naas Road and may lead to pedestrians travelling over the tree pit, rather than diverting around it and into the development.

The tree pit should be removed or relocated such that the pedestrian desire line along the footway is not obstructed.

2.6	Tree Pit within Existing Footway	Footway along the Naas Road has been realigned to provide a continuous path, with no obstructions.
2.7	Street furniture on footway.	The footway along the Naas Road has been realigned 1.5m away from the current line of the kerb, which will provide a continuous, unobstructed path.

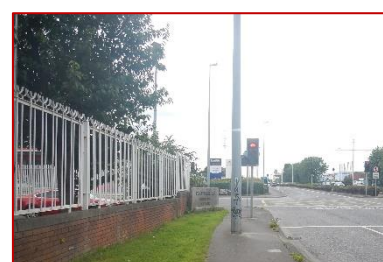
2.7 Street furniture on footway.

The existing lighting column, signal head and sign column are located in the middle of the footway along the Naas Road. This may create difficulties for vulnerable road users travelling within the footway.

All street furniture should be located/relocated to the rear of the footway and outside the pedestrian desire walking lines.

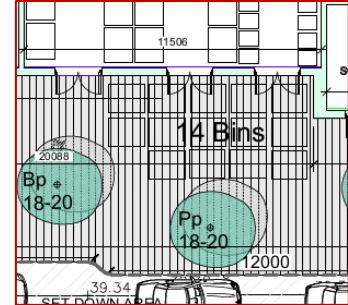
2.8 Obstacles within Internal Paths

Space for the storage of fourteen bins has been indicated within the development's shared surface at the edge of the Carriglea Industrial Estate Access Road such that they would block access/egress to/from Block 2.

The bin storage area should be relocated where it would not block access, or present obstacles, for non-motorised road users.

2.8	Obstacles within Internal Paths	The area indicated is a temporary bin staging area for a very short period when the bins are being collected. The bins are typically stored internally in the bin store room.

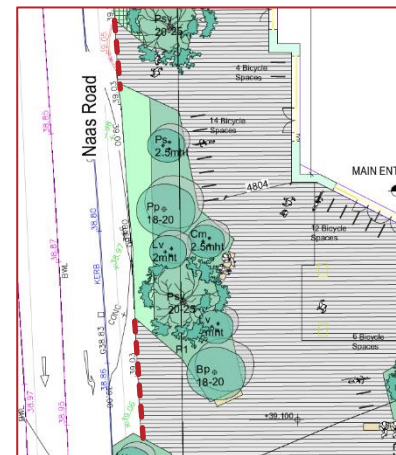
2.10 Transition between Public Footway and the Development's Shared Surface

The proposed development would be accessible to pedestrians traveling along the eastern side of the Naas Road at a number of locations. It is unclear if measures to delineate the development's shared surface from the public footway would be provided where the footway on the Naas Road intersects the shared surface within the development. Should none be provided, this may lead to visually impaired pedestrians inadvertently entering the shared surface within the development where they are at risk of being struck by a cyclist.

Delineation measures, such as warning tactile paving or contrasting surface material/colour, should be provided to advise visually impaired pedestrians, travelling on the Naas Road, of the development's shared surface.

2.9	Dropped Kerb at Mobility Parking Space	A continuous 2m wide route has also been provided adjacent to the kerb for pedestrians.
2.10	Transition between Public Footway and the Development's Shared Surface	Dropped kerbs have been added to the site layout.
