Development at Gowan Motors  
Site, Naas Road

Stage 1 Road Safety Audit

**Document Ref:** P23063-PMCE-XX-XX-RP-SA-RSA-3\_ZZ\_01

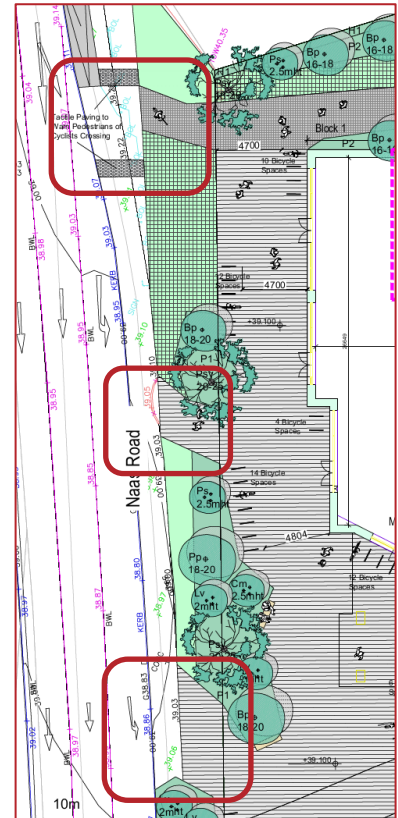
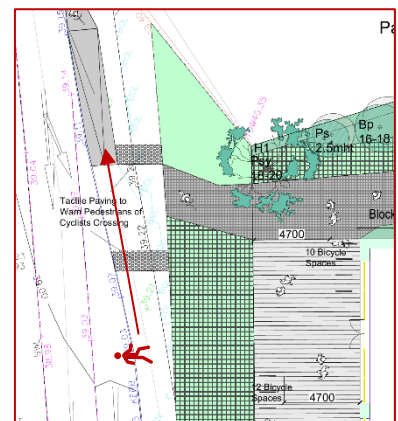
*Location:* Drawing 22-579-SDA-PD-DR-GF-001

*Summary:* The layout of the access at the northwest of the development, where cyclists are indicated as crossing the existing footpath, is unclear and may be confusing for visually impaired pedestrians.

Tactile paving has been indicated on both sides of the access at the northwest of the proposed development where it is intended that cyclists would travel between the Naas Road and the development's underground Bike Store via this access. A ramp has been indicated at this location to allow cyclists to leave the Naas Road carriageway and enter the development.

Tactile paving has been indicated within the footpath on both sides of this access however the type of tactile paving proposed is unclear. Should 'Ladder and Tramline' tactile paving not be provided on the north-eastern side of the access where the footpath and cycle track transition to a shared path, this may result in visually impaired pedestrians, travelling northeast, inadvertently descending the ramp and entering the cycle track where they are at risk of being struck by a cyclist.

In addition, should warning tactile paving not be provided on the south-western side of the access, there is a risk that visually impaired pedestrians may be insufficiently aware that they have entered/exited an area shared with cyclists, increasing the risk of cyclist-pedestrian collisions.

'Ladder and Tramline' tactile paving, of an appropriate depth, should be provided on the north-eastern side of the access and warning tactile paving should be provided on the south-western side of the access where the segregated facilities transition to the shared surface.

The profile of the 'Ladder and Tramline,' and warning, tactile paving should be in accordance with, "Guidance on the Use of Tactile Paving Surfaces (2021)."

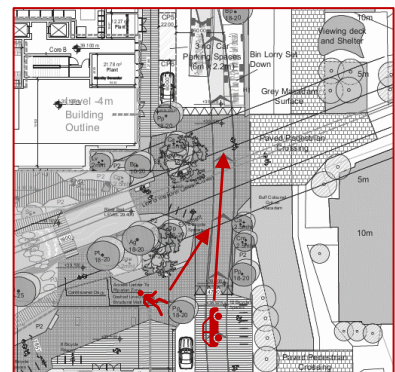
*Location: Drawing 22-579-SDA-PD-DR-GF-001*

*Summary: A designated 'safe zone' for visually impaired pedestrians has not been indicated within the development's shared surface, particularly where vehicles share the space with pedestrians and cyclists.*

A shared surface which would be traversed by vehicles, cyclists, and pedestrians has been indicated within the proposed development, however, a designated 'safe zone' has not been provided within this surface for visually impaired pedestrians where they can travel without having to share space with motorised vehicles. The absence of a 'safe zone' within areas shared by all road users may lead to an increased risk of vehicle-pedestrian collisions and, in addition, lead to visually impaired pedestrians being unable to safely and independently navigate through the development.

A designated 'safe zone' denoted by, for example, a strip of guidance tactile paving, or similar measures, should be provided to guide visually impaired pedestrians through areas shared with motorised vehicles.

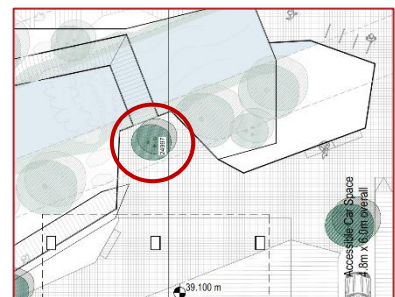
*Location: Drawing GWH-HKR-XX-00-DR-A-0200*

*Summary: Trees within the shared surface may present a hazard to pedestrians and cyclists.*

Trees have been indicated within the shared surface at various locations within the proposed development such that they would obstruct pedestrian and cyclist routes, presenting a hazard to these road users and resulting in personal injury collisions if struck.

This is of particular concern where a tree has been indicated at the eastern access to the pedestrian footbridge adjacent to the River Camac, however it is noted that a tree has not been indicated at this location on all drawings provided.

Trees should not be located within the expected path of pedestrians and cyclists and, in addition, the location of trees should be consistent throughout the design drawings to reduce the risk of confusion.

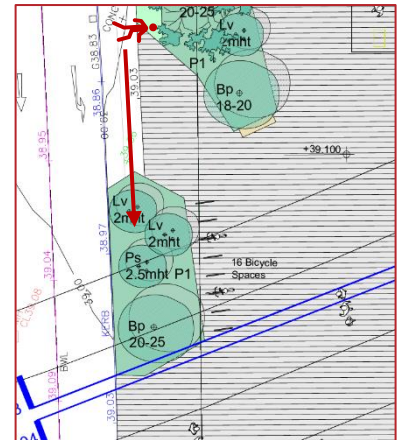
*Location:* Drawing 22-579-SDA-PD-DR-GF-001

*Summary:* The pedestrian desire line along the existing footpath on the eastern side of the Naas Road would be blocked by a tree pit.

A tree pit has been indicated within the existing footpath on the Naas Road at the southwest of the proposed development. This would obstruct the desire line of pedestrians travelling along the existing footpath on the Naas Road and may lead to pedestrians travelling over the tree pit, rather than diverting around it and into the development, where there is a risk of trips and falls.

The tree pit should be removed or relocated such that the pedestrian desire line along the footpath is not obstructed.

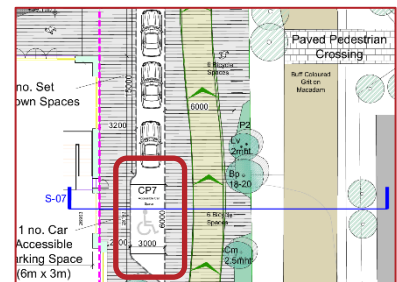
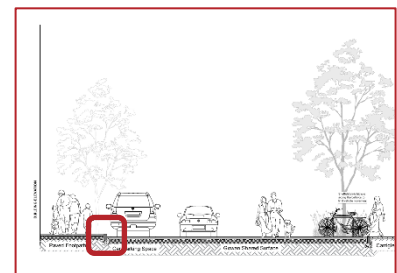
*Location:* Drawings 22-579-SDA-PD-DR-GF-001 & 22-579-SDA-PD-DR-XX-201

*Summary:* No dropped kerb, and tactile paving has been indicated at the mobility parking space within the proposed development.

A dropped kerb, and associated tactile paving, should be provided adjacent to the mobility impaired parking space.

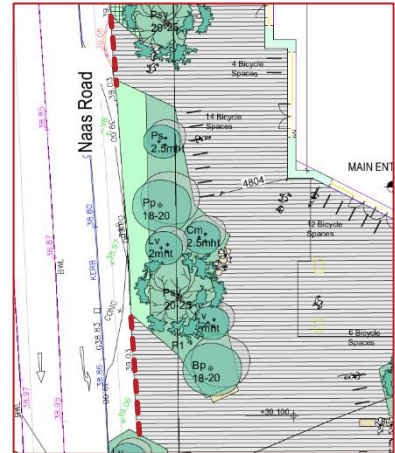
Location: Drawing 22-579-SDA-PD-DR-GF-001

The proposed development would be accessible to pedestrians traveling along the eastern side of the Naas Road at a number of locations. It is unclear if measures to delineate the development’s shared surface from the public footpath would be provided where the footpath on the Naas Road intersects the shared surface within the development. Should none be provided, this may lead to visually impaired pedestrians inadvertently entering the shared surface within the development where they are at risk of being struck by a cyclist.

Delineation measures, such as warning tactile paving or contrasting surface material/colour, should be provided to advise visually impaired pedestrians, travelling on the Naas Road, of the development’s shared surface.

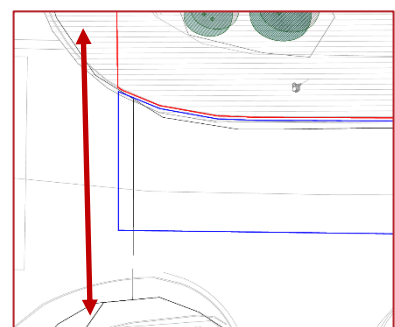
Location: Drawing GWH-HKR-XX-00-DR-A-0200

However, an additional drawing has been provided which indicates improvements to the Carriglea Estate Access Road, which include the provision of a signalised pedestrian crossing at this location. It is, however, unclear if this crossing would be constructed, and therefore in operation, at the time of the development’s opening.

If no pedestrian crossing is provided at the access road, this could lead to mobility and visually impaired pedestrians experiencing difficulties crossing the road to access the development from the southwest resulting in personal injuries as pedestrians attempt to ascend/descend the kerbs.

In addition, the absence of a crossing may lead to pedestrians crossing at locations where drivers may be less attentive to them, increasing the risk of vehicle-pedestrian collisions.

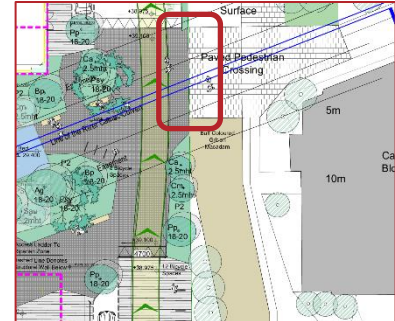
A 'Paved Pedestrian Crossing' has been indicated at the development's eastern boundary with the adjacent Carriglea Development. This crossing would tie-in to the proposed development's shared surface within the vehicular route. Cross section 'S-04' indicates that there would be no level difference between the development's shared surface and this crossing in the Carriglea Development. It is, therefore, unclear if vehicles would be able to access the proposed development from the Carriglea Development at this location.

Should vehicles not be permitted to travel between the two developments at this location, and no vehicle deterrent measures provided, there is a risk that a driver may enter the development at this location where road users may be less attentive to them, increasing the risk of collisions.

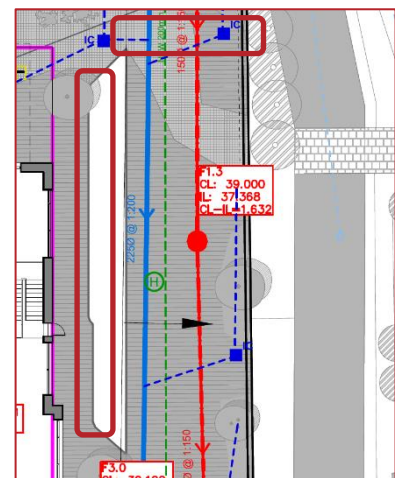
If sufficient drainage measures are not provided at these locations there is an increased risk of ponding which may lead to loss of traction for vehicles and cyclists, and slips and falls for pedestrians, particularly during times of cold and icy weather, resulting in material damage to vehicles and personal injuries to pedestrians and cyclists.

Sufficient drainage measures should be provided throughout the proposed development to prevent ponding.

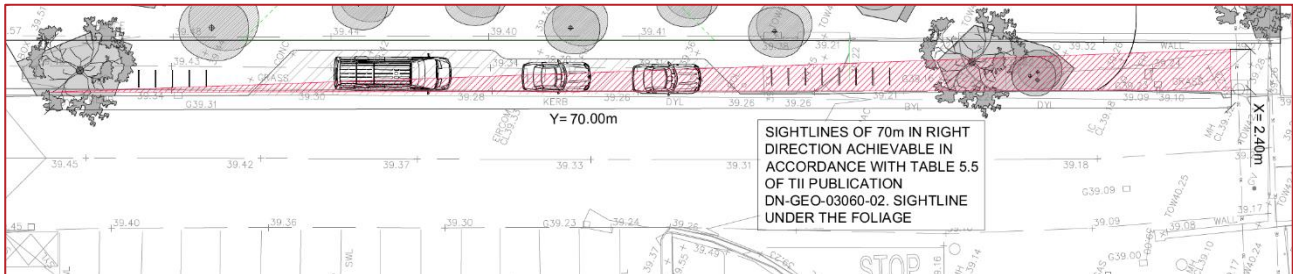
**Location:** Drawing GWH-BMD-ZZ-00-DR-C-1004 (Rev. PL1)

**Summary:** The visibility splay for drivers exiting the development onto the Carriglea Industrial Estate Access Road is indicated as passing through trees/vegetation, bicycle parking stands and the set down area.

A visibility splay has been provided for drivers exiting the proposed development onto the Carriglea Industrial Estate Access Road. The visibility splay is indicated as passing through trees/vegetation, bicycle parking stands and the set down area. While there is a note on the drawing indicating that a driver's visibility would be below the foliage of the trees, visibility for an exiting driver towards an oncoming vehicle may be restricted by bicycles parked at the bicycle stands or vehicles parked within the set down area. This could lead to drivers exiting the development when it is unsafe to do so resulting in side-on collisions with vehicles on the Carriglea Industrial Estate Access Road.

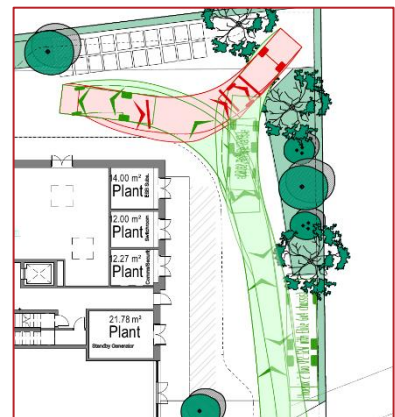
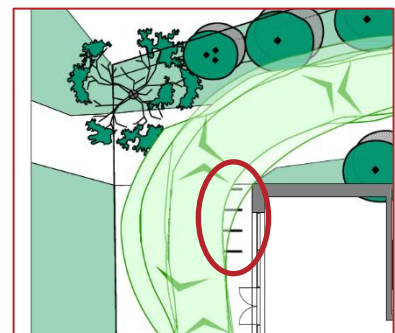
The swept path of a refuse truck is indicated as conflicting with an area that may include tree canopies as it traverses through the development. While this is unlikely to lead to material damage to the vehicle it may lead to branches of trees being knocked into the carriageway or shared surface where they may present hazards to smaller vehicles, resulting in material damage if struck, or non-motorised road users, resulting in personal injuries.

Similarly, the swept path of a fire tender is indicated as passing through bicycle parking stands adjacent to Block 1 which would result in material damage to the bicycle parking stands, or bicycles parked there if occupied.

All vehicles should be able to safely travel through the development without conflicting with vegetation or items of roadside furniture.

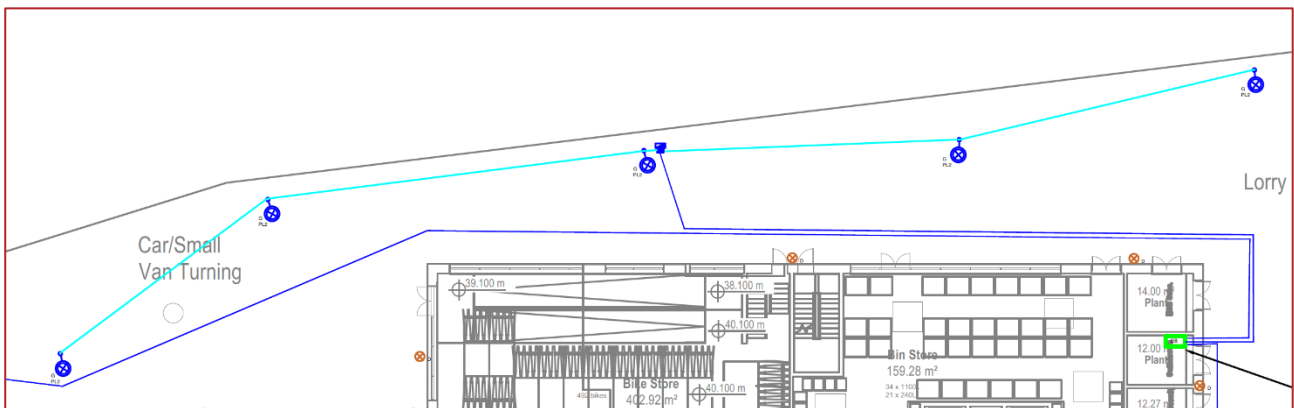
*Summary: Some of the public lighting columns within the proposed development have been indicated within the vehicle route, adjacent to trees and at building access.*

A number of public lighting columns have been indicated throughout the proposed development. Although unclear, some of these appear to be located within the vehicular route along the eastern and northern sides of Blocks 1 and 2, and within the car/small van turning circle, where they would be at risk of being struck by a vehicle resulting in material damage.

Similarly, some public lighting columns have been indicated where they would be located adjacent to trees. The height of the luminaires of the lighting columns, relative to the tree canopies, is unclear at this early stage in the design process however, should the tree canopy and luminaires be at the same height, the tree canopies may block the luminaire preventing it from sufficiently illuminating the development. This could lead to dark spots within the development resulting in reduced inter-visibility between road users and an increased risk of collisions.

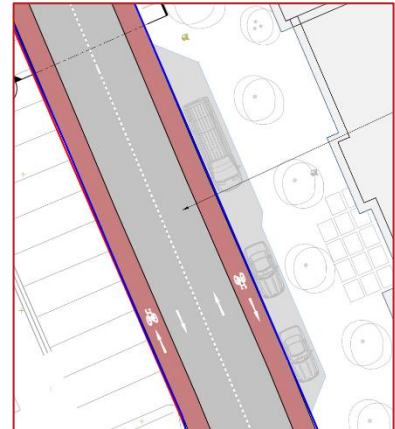
*Summary: Vehicle occupants opening car doors when stopped in the set down area may present a hazard to cyclists within the inbound cycle lane.*

It is proposed to upgrade the road layout on the Carriglea Industrial Estate Access Road to provide cycle lanes in each direction. The inbound cycle lane is indicated as running directly adjacent to the proposed development's set down area in front of Block 2. A buffer zone has not been indicated between the cycle lane and set down area and this could lead to the occupant of a vehicle within the set down area opening the door of their vehicle into the path of an oncoming cyclist resulting in collisions and personal injuries, or to cyclists suddenly swerving into the adjacent traffic lane to avoid an open door where there is an increased risk of being struck by a vehicle.

A buffer zone should be provided between the cycle lane and set down area such that an open vehicle door would not encroach into the cycle lane.

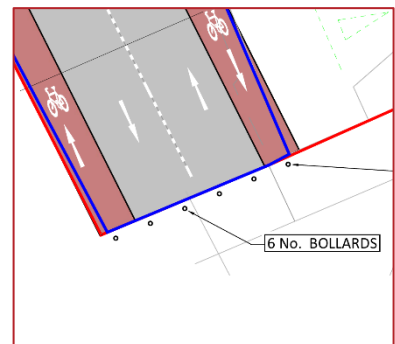
Six bollards, which are part of the adjacent Carriglea Development, have been indicated at the end of the Carriglea Industrial Estate Access Road. Details in relation to the type of bollards proposed have not been provided and it is, therefore, unclear if the bollards would be visible during the hours of darkness. If the bollards are not sufficiently visible during the hours of darkness there is an increased risk of drivers and cyclists colliding with the bollards resulting in material damage and personal injuries, respectively.

In addition, two of the bollards are located centrally within the inbound and outbound cycle lanes, further increasing the risk of cyclists colliding with the bollards.

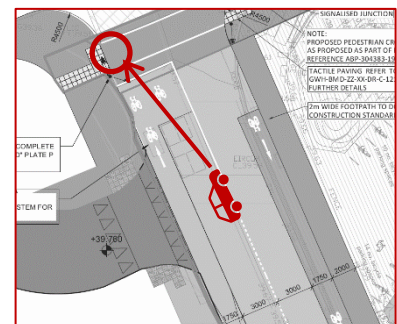
*Location:* Drawing No. GWH-BMD-ZZ-XX-DR-C-1012 (Rev. P5)

A new "Cycle Track End" sign (RUS 009) has been indicated on the western side of the access road to the proposed development. The exact location of the sign is unclear, however it appears that it would be located immediately upstream of the primary traffic signal pole. This may result in the sign partially blocking the signal aspects and impeding an approaching driver's visibility towards the signal head. Reduced visibility to the primary signal head may lead to drivers being insufficiently aware of a red signal at the junction, reducing the time they would have to react, resulting in possible overshoot type incidents and collisions with pedestrians using the crossing, or side-on collisions with vehicles on the Naas Road.

The sign should be relocated, so as not to restrict an approaching driver's visibility towards the signal head.

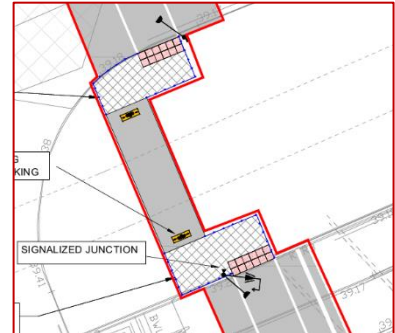
It is unclear if the guardrails would be sufficiently setback such that they would provide the necessary clearance to the edge of the carriageway and the Luas track. If the pedestrian guardrails are not sufficiently setback, there is an increased risk of vehicle strikes and material damage.

The pedestrian guardrails should be setback a minimum of 450mm from the edge of the carriageway and Luas tracks.

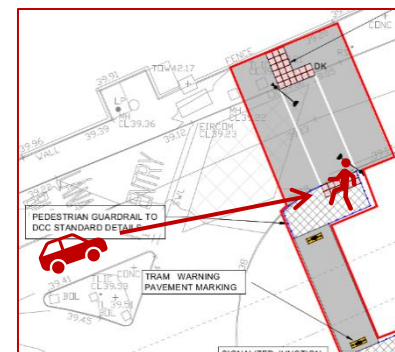
Should insufficient inter-visibility be provided between drivers and pedestrians, this may lead to pedestrians undertaking a crossing when it is unsafe to do so and to drivers having insufficient time to react to a pedestrian crossing the carriageway, resulting in potential vehicle/pedestrian collisions.

A high-visibility pedestrian guardrail should be provided which would not restrict inter-visibility between drivers and pedestrians waiting within the refuge islands.

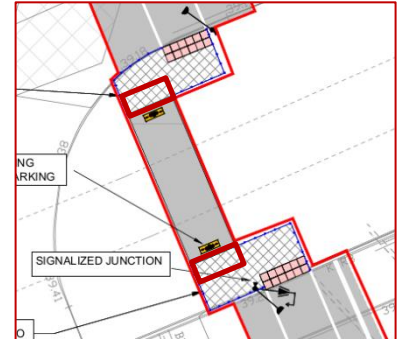
The proposed crossing of the Naas Road includes a crossing of the Luas tracks, however no tactile paving has been indicated on either side of the Luas line to advise visually-impaired pedestrians of the upcoming hazard. This may lead to visually-impaired pedestrians being insufficiently aware of the tracks, resulting in them inadvertently entering the tracks where there is an increased risk of being struck by a Luas.

Measures should be provided on both sides of the tram crossings to advise visually impaired pedestrians of the Luas track.

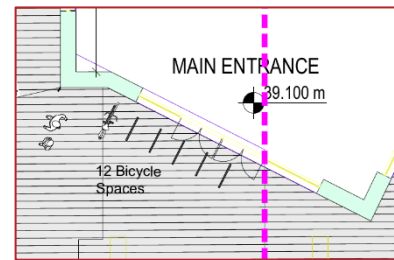
4.1.1 Bicycle parking stands have been indicated within the development's shared surface adjacent to the main entrance to Block 1 such that they would block a pedestrian's access/egress to/from Block 1, particularly when the stands are occupied. The bicycle parking stands should be relocated where they will not present an obstacle to non-motorised road users.

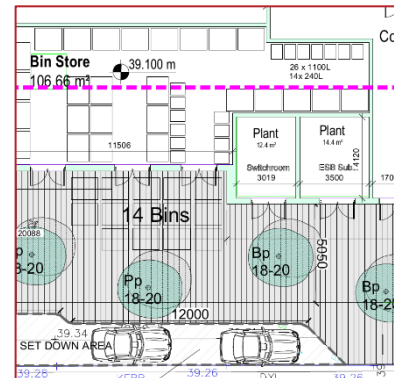
4.1.2 Space for the storage of fourteen bins has been indicated within the development's shared surface at the edge of the Carriglea Industrial Estate Access Road such that they would block access/egress to/from Block 2. The bin storage area should be relocated where it would not block access, or present obstacles, for non-motorised road users.

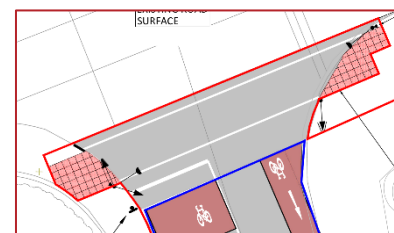
4.1.4 As indicated in Drawing No. GWH-BMD-ZZ-XX-DR-C-1010 (Rev. P3), it is proposed to upgrade the road layout on the Carriglea Industrial Estate Access Road to provide cycle lanes in each direction and a new signalised pedestrian crossing at the access road at its junction with the Naas Road. Tactile paving has been indicated on both sides of the proposed signalised pedestrian crossing.

However, on the western side of the crossing a stem has not been indicated within the tactile paving layout, presumably due to the adjacent boundary at this location. Similarly, on the eastern side of the crossing, the stem indicated does not extend a sufficient distance from the crossing.

If possible, and where constraints allow, the layout of the tactile paving on both sides of the signalised pedestrian crossing should be amended to be in accordance with the document, "Guidance on the Use of Tactile Paving Surfaces."

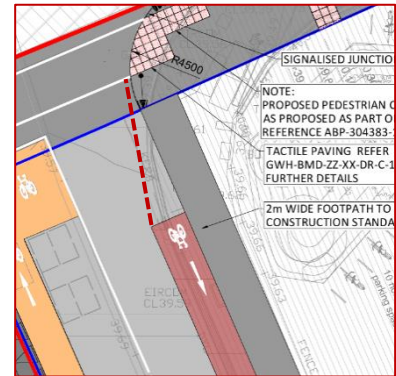
- 4.2.1 The cycle lane indicated on the eastern side of the development access road commences downstream of the access road's junction with the Naas Road. This may lead to cyclists and drivers being insufficiently aware of the cycle lane when entering the access road and adopting a position in the carriageway that would fail to correctly guide or direct users to the correct facility downstream.

The cycle lane should be extended to the Naas Road via an appropriate taper with a dashed line road marking to better advise drivers of the cycle lane and to guide cyclists into the cycle lane.

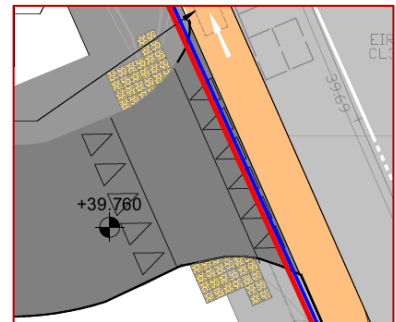
- 4.2.2 The tactile paving layout indicated at the crossing of the access on the western side of the development access road is incorrect for an in-line uncontrolled pedestrian crossing. The tactile paving layout at this location should be amended, and the stem indicated removed, to provide tactile paving with a depth of at least 1.2m across the full width of the crossing.

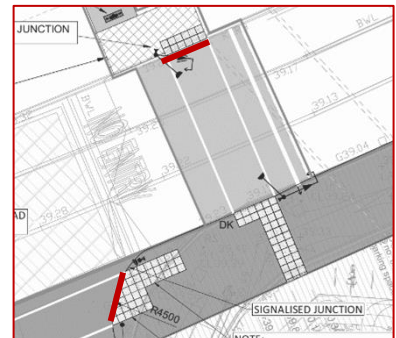
- 4.2.3 The label "DK" has been indicated adjacent to a number of the pedestrian crossing points. It is assumed that this text denotes that a dropped kerb would be provided at these locations. However, it is unclear if a dropped kerb would be provided where this label has not been indicated, such as at the refuge island crossings and the crossing of the development access road. Dropped kerbs should be provided at all pedestrian crossing points.

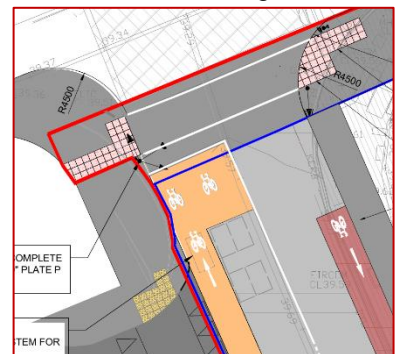
- 4.2.4 An Advance Stop Line for cyclists has been indicated on the development access road at its junction with the Naas Road. However, it is unclear if cyclists exiting the side road would receive an advance green signal prior to motorised vehicles. Should none be provided this may lead to an increased risk of conflicts between right-turning cyclists and left-turning vehicles. The provision of an advance green signal for cyclists at this location should be considered during the traffic signal development stage of the design.

In addition, a smart detection system for cyclists has been indicated upstream of the Advance Stop Line for cyclists. It is unclear if this detection system would detect cyclists as they traverse the loop or if cyclists would need to be stopped on the loop to trigger a green phase. If cyclists would be required to be stopped on the loop to trigger a cyclist phase then the loop is located upstream of where cyclists would likely be stopped at the junction, and should, therefore, be relocated.
