Malclose Limited Proposed Development at Gowan House, Carriglea Business Park, Naas Road, Dublin 12, D12 RCC4

November 2023

Client	Malclose Limited
Project Title	Proposed Development at Gowan House, Carriglea Business Park, Naas Road, Dublin 12, D12 RCC4
Document Title	Bat Activity Survey Report

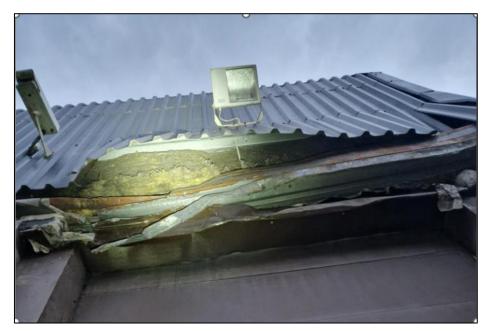
The linear habitat features such as the treelines within the Site were assessed for bat roosting potential and foraging/commuting suitability. The treelines on-Site were composed of a variety of species including lime, ash and sycamore. All of trees on-Site were considered to be of *Negligible* bat roost potential given the lack of PRFs as outlined in Table 4.1 in the BCT's *Bat Surveys for Professional Ecologists: Good Practice Guidelines* (Collins, 2016). Overall, the buildings on site were considered to be of *Low* bat roost potential. However, there was some

damage to the building envelope at loading bay on the northern face of the main building which could act as an ingress/egress point for opportunistic bats (Figure 4).

FIGURE 4. DAMAGE TO THE EXTERIOR OF THE MAIN BUILDING WHICH MAY PROVIDE ROOSTING OPPORTUNITIES FOR BATS.

During the dedicated bat emergence survey on the 21<sup>st</sup> of August 2023, a single common pipistrelle was recorded emerging from above the right loading bay on the north side of the building at 21:05, which then commuted west and was recorded by the surveyor within the northwest of the Site. An area of damage above the door, as seen in Figure 4, provides an access/egress point for opportunistic local bats. No other PRFs were recorded within the Site of the Proposed Development and no further bat activity was recorded during this survey following the observation of the emergence of one individual common pipistrelle (see Table 4 and Figure 6). As such, based on the limited activity recorded at the Site during the two surveys, and the *Low* habitat suitability for foraging and commuting, the building is assessed as a day roost for local bats (i.e., "a place where individual bats, or small groups or males, rest or shelter during the day but are rarely found by night in the summer" (Collins, 2016)).

Although the Site was deemed to contain low suitability habitats for bats, a bat emergence from the building was recorded. As such, a derogation licence from the NPWS will be required prior to demolition of the building on Site. An application for a derogation license regarding the demolition of the building on Site was sought on the 23<sup>rd</sup> of October 2023, however this was refused by the NPWS on the 22<sup>nd</sup> of November 2023. This refusal was due to timing of works, as the proposed demolition is scheduled for March 2025. The NPWS recommended an application for a derogation license be submitted closer to the start date of the Proposed Development works.

- Galvanized sheeting along the damaged areas identified as potential ingress/egress point on the building will be removed manually using handheld tools. This will enable bats, if present, to escape unharmed. The building will not be demolished using mechanical excavator.

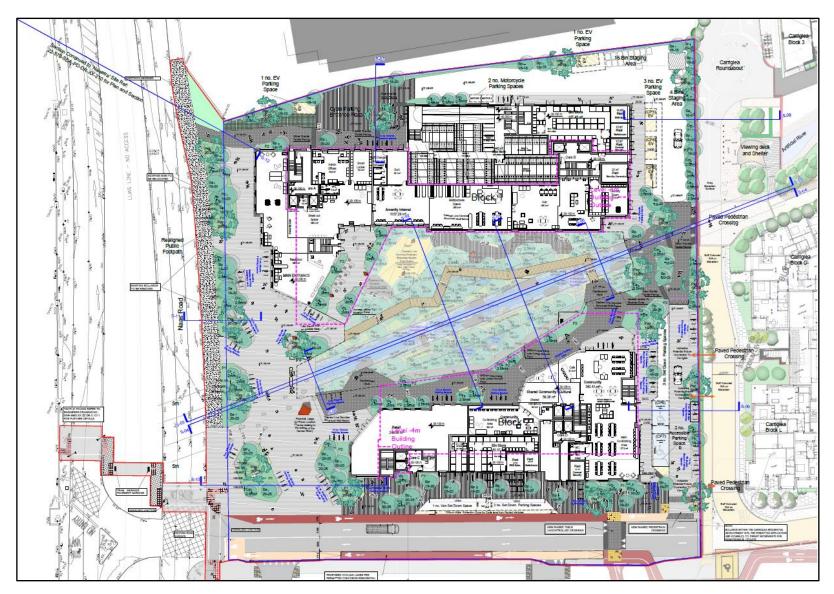
FIGURE 7. LOWER GROUND FLOOR MASTERPLAN. DRAWING NUMBER: 22-579-SDA-PD-DR-GF-001 (STEPHEN DIAMOND ASSOCIATES, 2023).

The proposed riparian habitats and planting included as part of the landscaping to take place on Site will offer potential commuting and foraging habitat for any locally occurring bats (Figure 7). This is considered to improve the foraging and commuting habitats for bats at the Site, and to increase the habitat suitability assessment to 'Moderate' after a period of establishment. As such, the likely impact is considered *positive*, *permanent*, *moderate* at a *local* level due to the increase of available resources and habitats on Site.
